Ballard School

Project: Ballard School

Task: Exterior Repair and Redecoration

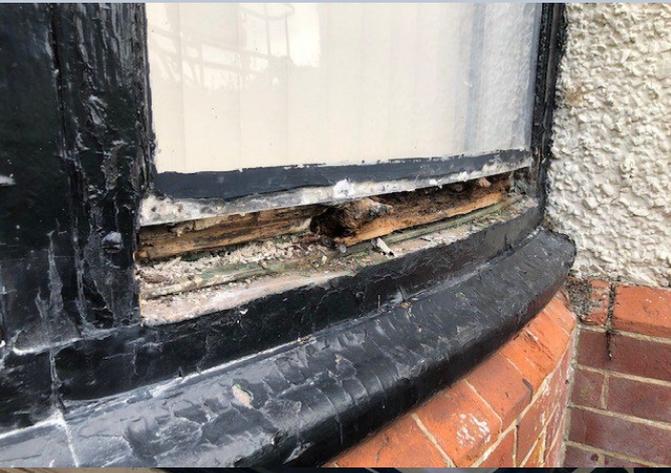
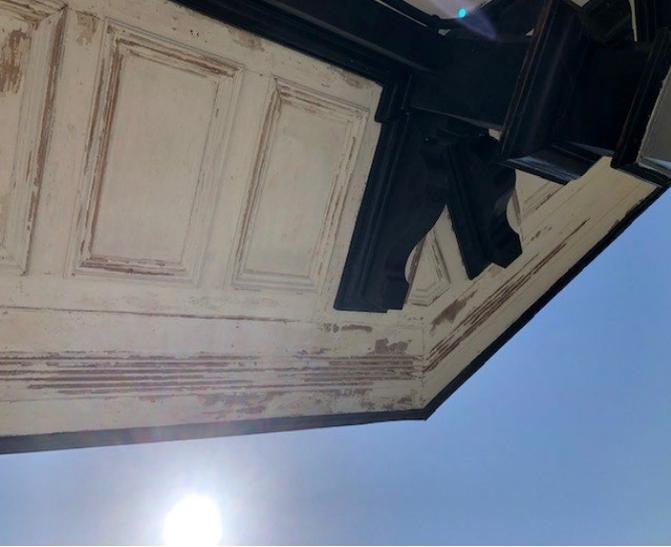
Exterior: whilst paint finishes appeared to be generally in a sound condition, localised adhesion failures were evident to the window surrounds, and localised organic growth contaminants were apparent. We tackled these technical challenges, with support from Crown Paints, including: manually removing loose and falling material, mechanically removing organic growth with Sandtex Trade Fungicidal Wash (taking care not to allow residues to run directly into watercourses), ensuring coping stone joints and ledges repaired to prevent moisture ingress to the structure below, stabilised previously decorated chalking surfaces, patch primes repaired areas and finished by applying two full-bodied coats of specified masonry paint with an airless spray for roughcast render equipment. **Without these measures, adhesion failures would return and moisture ingress would have damaged the structure below.**

- **Timberwork:** Existing finishes were in very poor condition in many areas. Grey and denatured surfaces were evident in some areas and localised growth contamination was apparent. We tackled these technical challenges, with support from Crown paints, by using preservative treatment and two-pack proprietary wood-filler (ensuring optimum performance by using it only on bare timber and dipping for a minimum of one minute), repaired timber back to a sound edge (with some requiring a strip-back to a natural joint), applied two coats of Sadolin Wood Preserver to saturation on all exposed surfaces, fixed holes and shallow surface defects, repaired open joints in window/doorframes and doors with Sandtex Ready Mixed Filler before rubbing down with abrasive paper, spot-primed, and once the surfaces were sound and clean applied two coats of gloss and used perimeter sealant to prevent water ingress. **Without these measures, a new finish would have degraded fast, and growth contamination would have quickly returned.**

- **Metal work:** Existing paintwork was in a poor condition with localised corrosion and organic growth contamination. We tackled this technical preparation challenge by removing and replacing broken and severely corroded metal sections to match existing, applied Crown Trade Fungicidal solution, applied Black Bitumous paint to ferrous metal gutters and hopper heads, spot primed ferrous metalwork coatings, stripe coated nuts, bolts and rivets to inhibit rust, brought forwards spot-primed areas before applying full High Build Rust Inhibiting Metal Primer/Undercoat. **Without these measures, there would have been a health and safety risk owing to unseen corrosion causing weaknesses.**

Roughcast render spray work: the decision to airless spray the entire roughcast render exterior was based on the time limitations of the client and the large area that would require a first-time pass uniform finish to be ready for open day. By teaming up with Crown, who informed our specification, we were able to achieve these goals for the client.

Technical Preparation within given timescale: we collaborated with Crown to undertake a survey, ensuring all relevant information about the surfaces were known to Crown so their specification could be prepared. Efficient planning and preparation avoided delays, no snagging of non-compliant finishes was needed. Optimum performance measures were undertaken to ensure we reduced the time needed for further maintenance of this kind in the future. Measures taken to address the preparation challenges are outlined in detail below:
