Ian Williams  
on behalf of Trinity House:  
**Lizard and Pendeen  
Lighthouses, Cornwall**

# Project: Lizard and Pendeen Lighthouses, Cornwall

**Task:** Prepare and paint historic lighthouses and their outbuildings during the height of the tourist season

**Client:** Trinity House

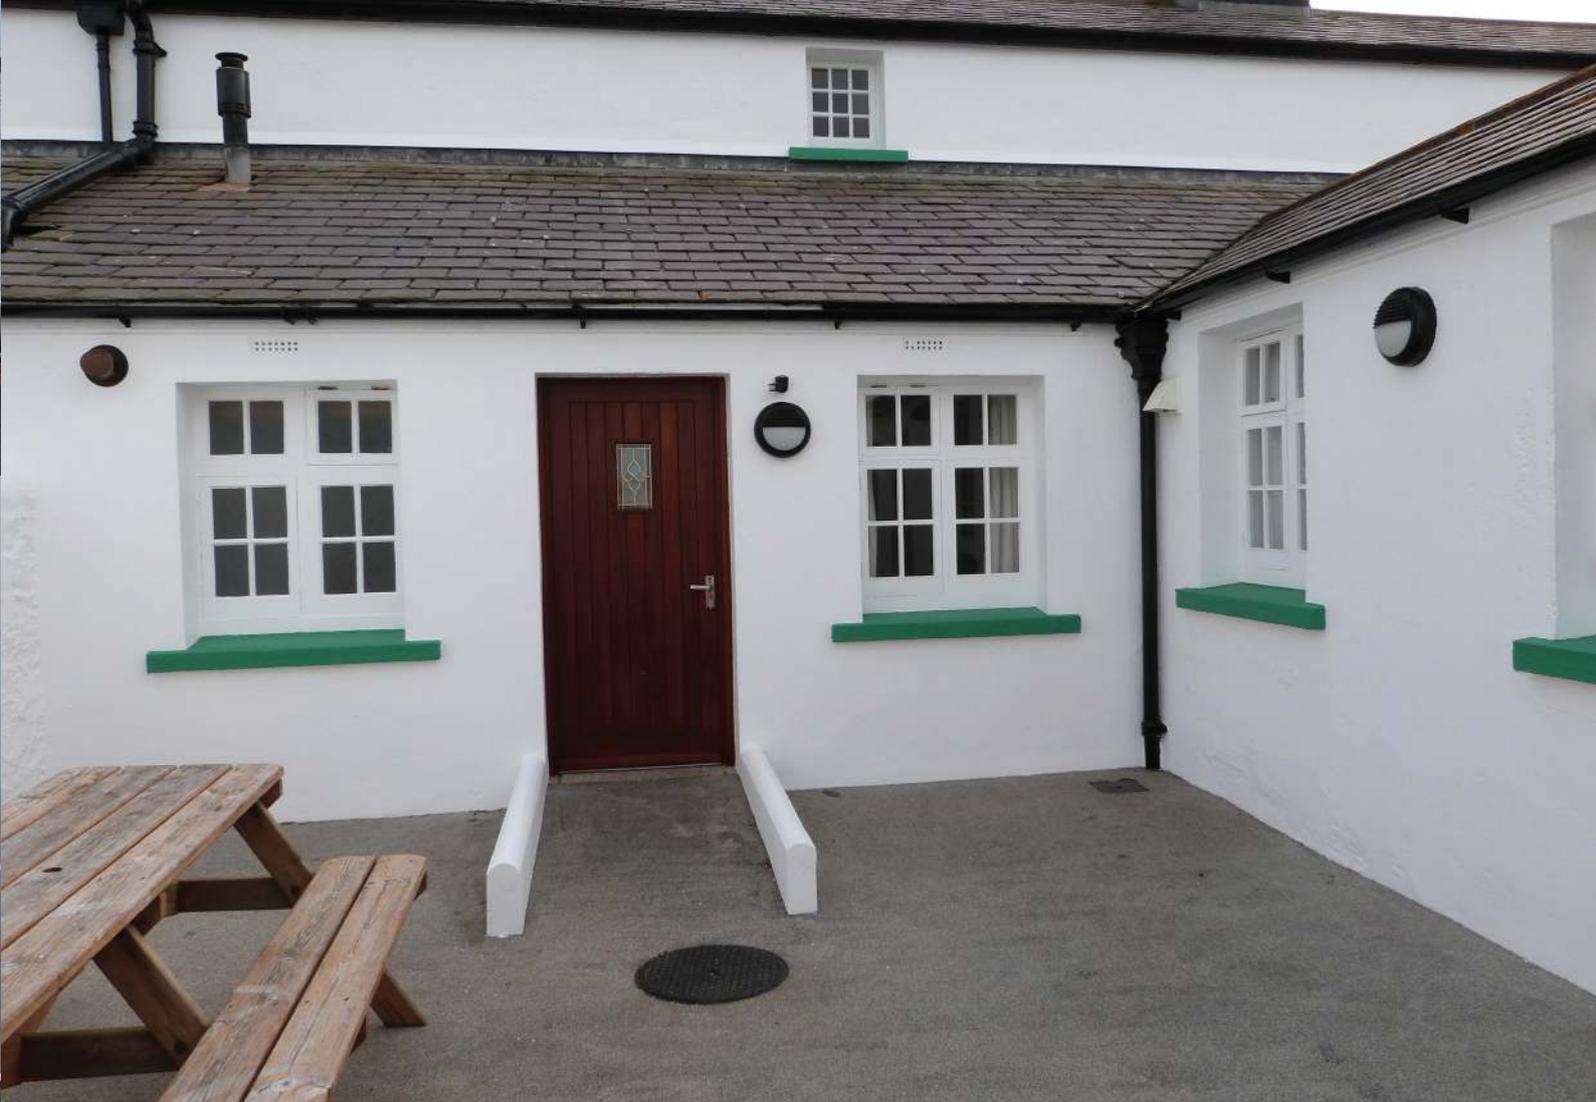
There are two octagonal towers, measuring 19m in height. The light is exhibited from the East Tower. The West Tower was discontinued in the 1870s and now houses the GPS antenna for Differential Global Positioning System (DGPS) station. There are connecting lobbies, various stores, public toilets and garages. There are also seven two-storey connected dwellings which are used as holiday lets.

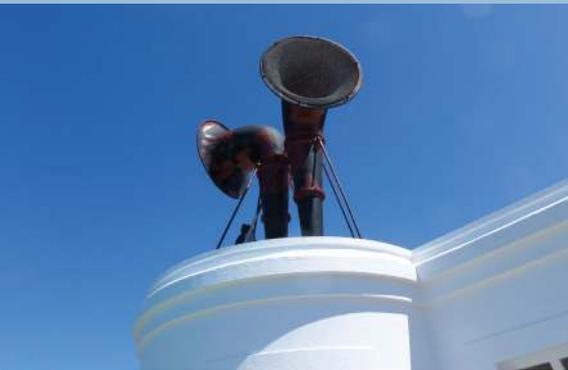
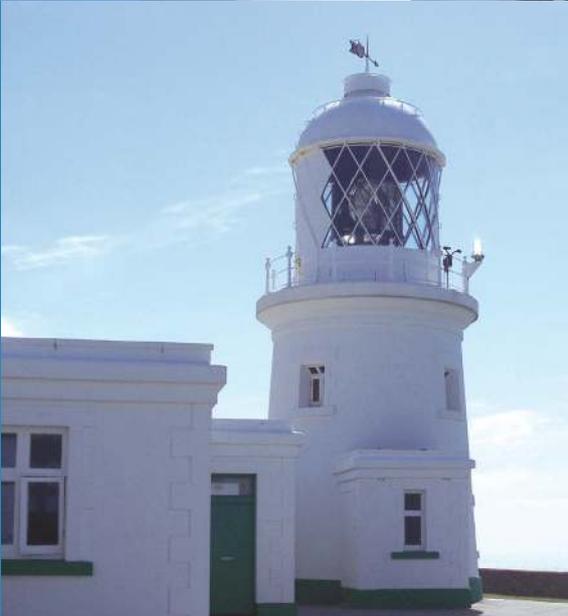
## Pendeen Lighthouse:

The lighthouse is a white rendered granite tower, 17m in height, with a single storey accommodation block comprising of four dwellings, day facilities, outbuildings, garages, a fog signal house and an engine room.

Within the tower are two rooms on two levels and on a third floor, the lantern which originally contained a five-wick Argand lamp. This lamp was replaced by an electric one in 1926. The original oil lamp is now in on display at the Trinity House National Lighthouse Centre in Penzance.

The paints used on Pendeen were all specialist materials designed to withstand to the constant battering from the Atlantic Ocean, and Mathy's Rustoleum, Corroless and Sigma Coatings products were used on the main lighthouse.
