Ian Williams  
on behalf of Trinity House:  
**Lizard and Pendeen  
Lighthouses, Cornwall**

# Project: Lizard and Pendeen Lighthouses, Cornwall

**Task:** Prepare and paint historic lighthouses and their outbuildings during the height of the tourist season

**Client:** Trinity House

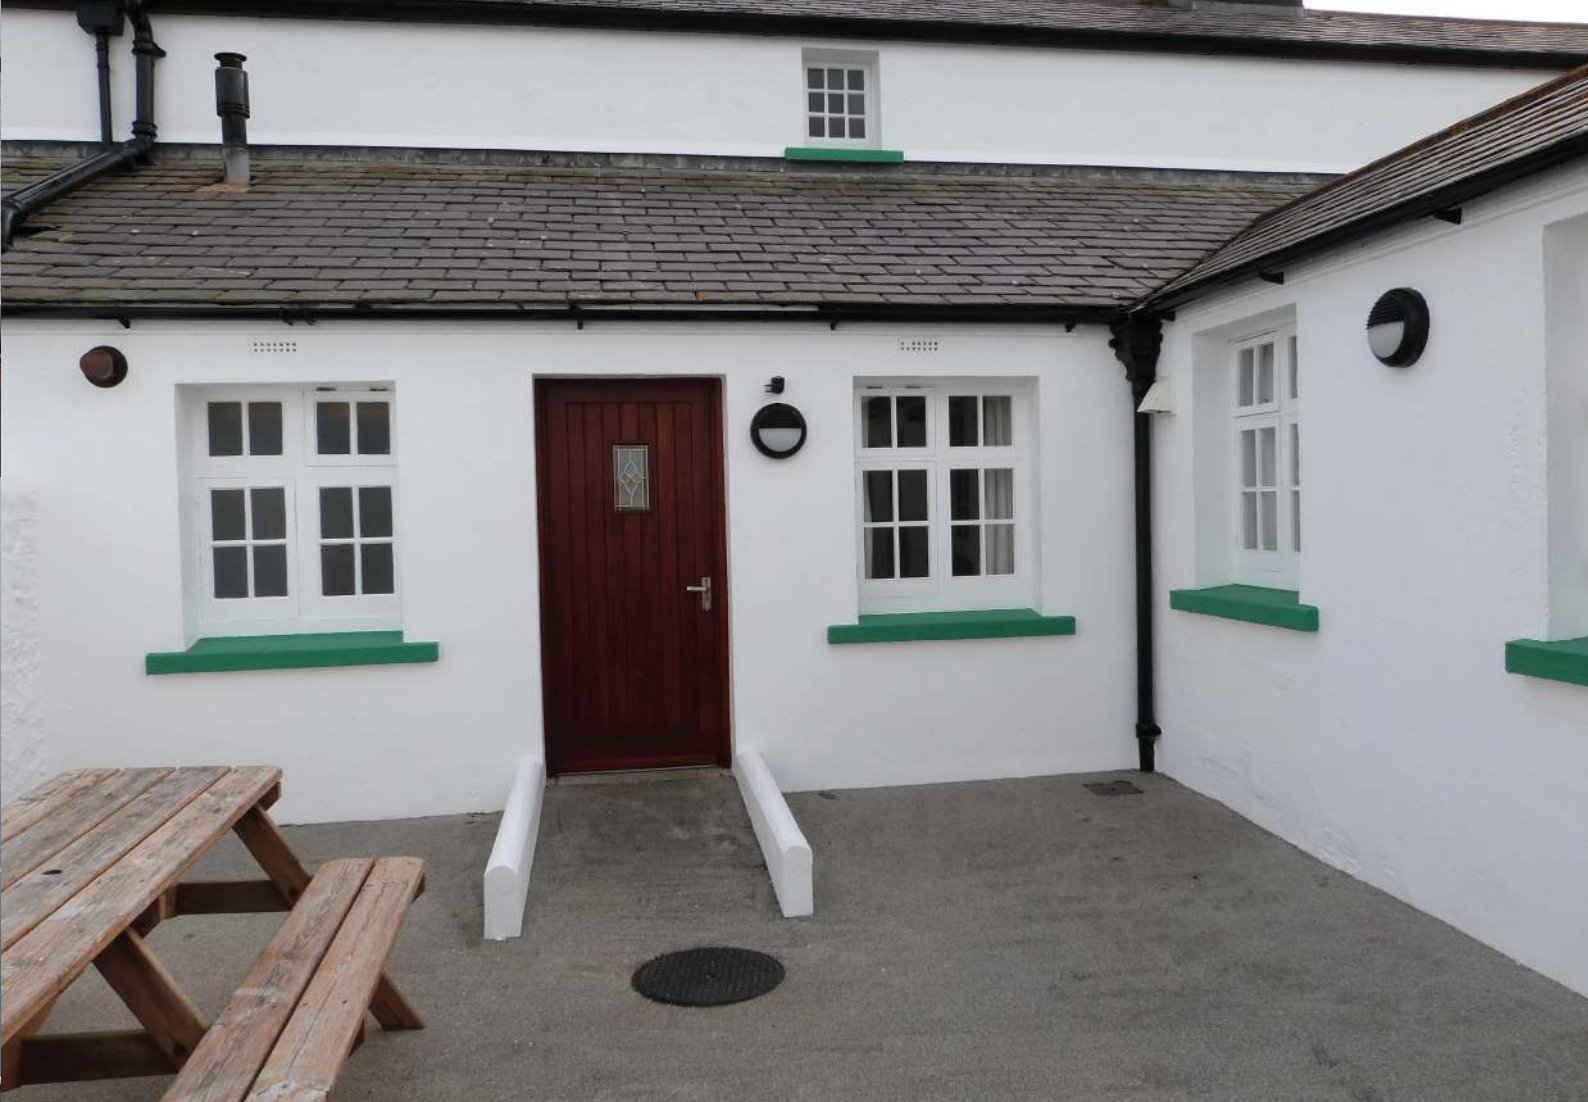
There are two octagonal towers, measuring 19m in height. The light is exhibited from the East Tower. The West Tower was discontinued in the 1870s and now houses the GPS antenna for Differential Global Positioning System (DGPS) station. There are connecting lobbies, various stores, public toilets and garages. There are also seven two-storey connected dwellings which are used as holiday lets.

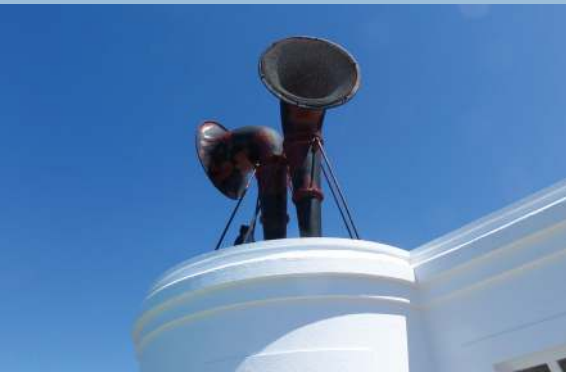
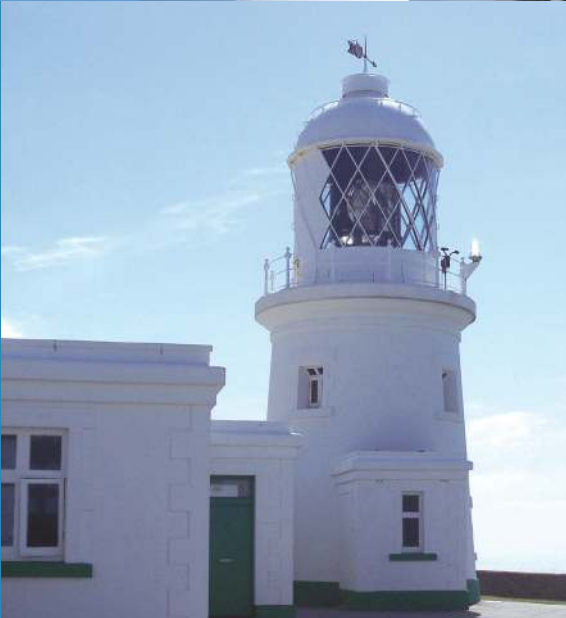
## Pendeen Lighthouse:

The lighthouse is a white rendered granite tower, 17m in height, with a single storey accommodation block comprising of four dwellings, day facilities, outbuildings, garages, a fog signal house and an engine room.

Within the tower are two rooms on two levels and on a third floor, the lantern which originally contained a five-wick Argand lamp. This lamp was replaced by an electric one in 1926. The original oil lamp is now in on display at the Trinity House National Lighthouse Centre in Penzance.
